June 12, 2025

## Golf Course News From the Superintendent

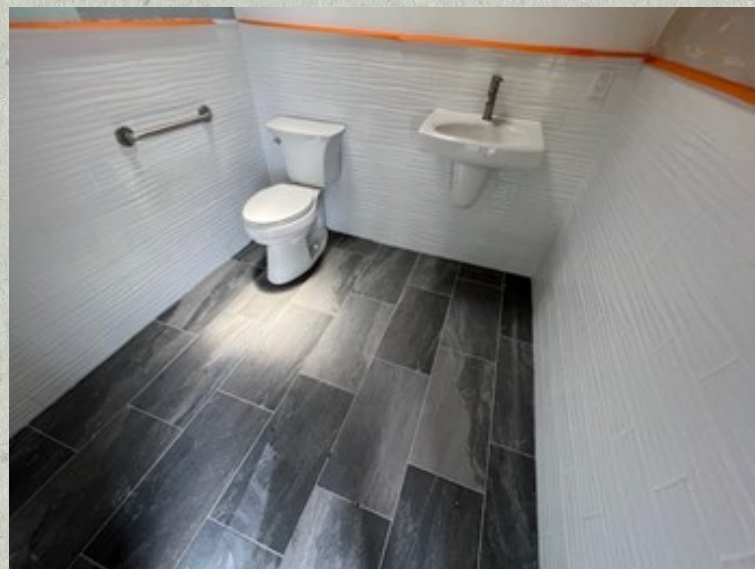
a few exceptions and surprises. The roof on number seven bathroom had three leaks above the soffits and a leak around one of the sky lights. These leaks resulted in rotten plywood decking, facias and three rafter tails. Due to the roofs age of 22 years, no spare tiles to fix the broken ones and three leaks with rot

on three different sides of the roof there was no choice but to replace the roof entirely. This part of the renovation unfortunately won't be completed for opening day, but the old roof has been removed and all the rotten wood has been replaced. The roofing contractor did install the new skylights and the weatherproof membrane for the time being and will come back to install the new tiles after they have been ordered and delivered. The painters are working today and as you can see, they are starting to look like bathrooms again.
